For a full detailed engineering report on the station, click here:
<http://www.ctrailgovernance.com/reports/Darien.pdf>

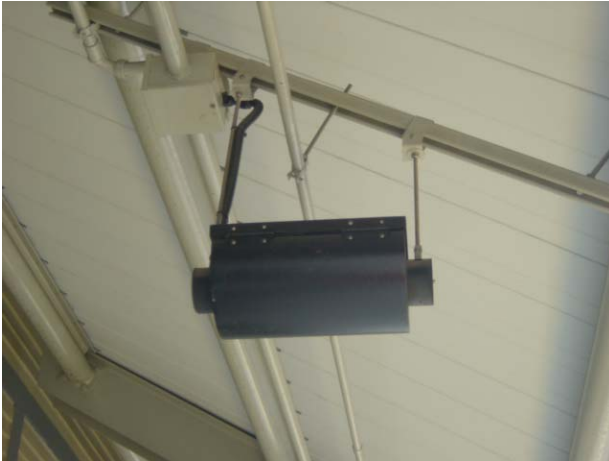
Indoor lights (used outdoors) fill with water when it rains, short circuiting all platform lights causing a blackout.

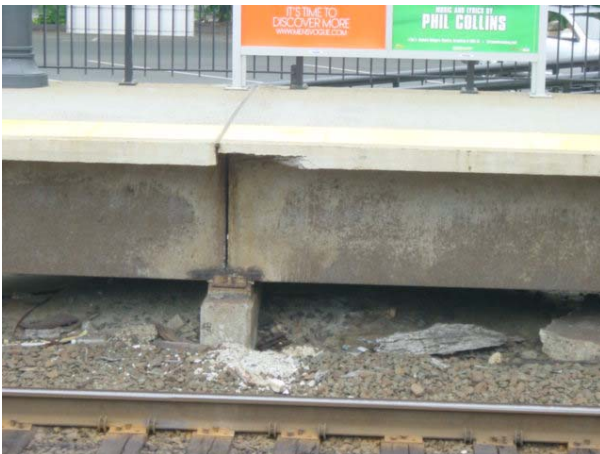
Platform crumbling from beneath – several locations, both sides.

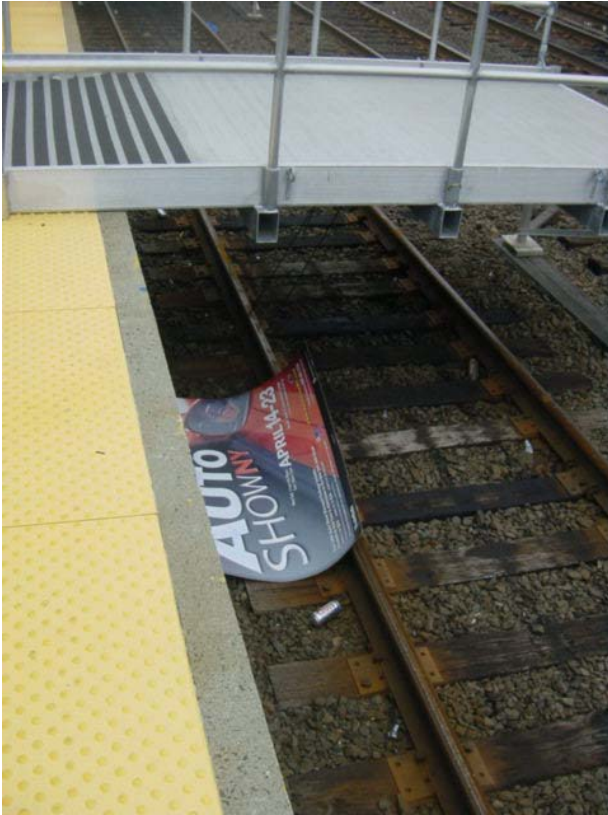
Trash on the tracks under bridge plates.

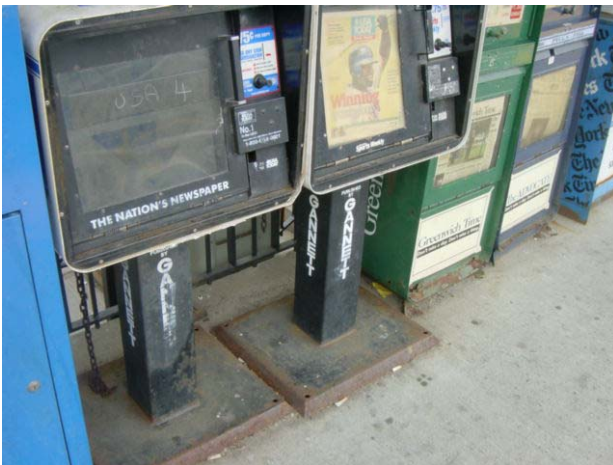
Old rusty (and unused?) paper boxes clog platforms.
