For a full detailed engineering report on the station, click here:  
<http://www.ct.gov/dotinfo/cwp/view.asp?a=2183&Q=295632&dotinfoNav>

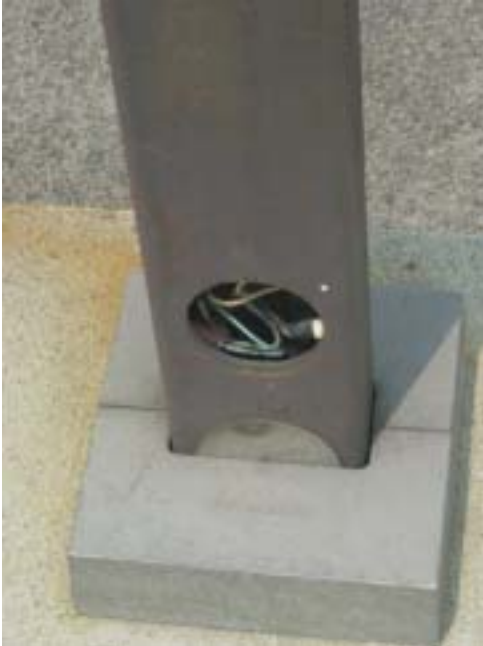
**Exposed electrical wiring.**

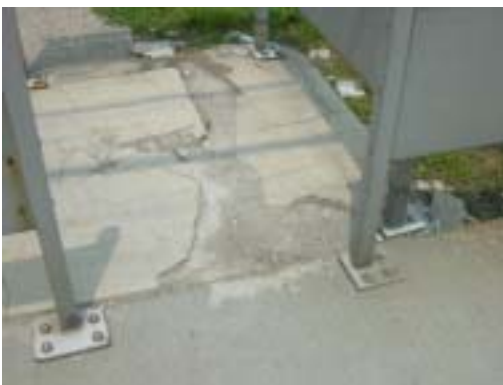
**Cracked concrete.**

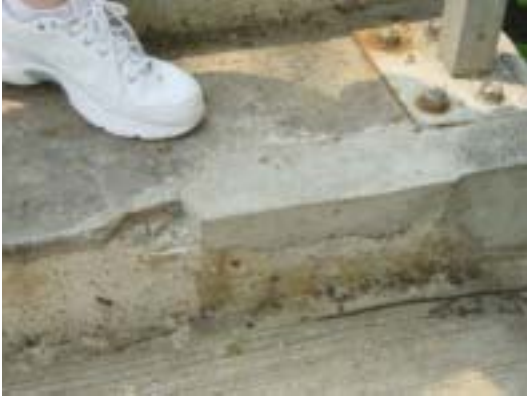
**Repaired, but broken again. Steps to Hollow Tree Ridge Rd.**

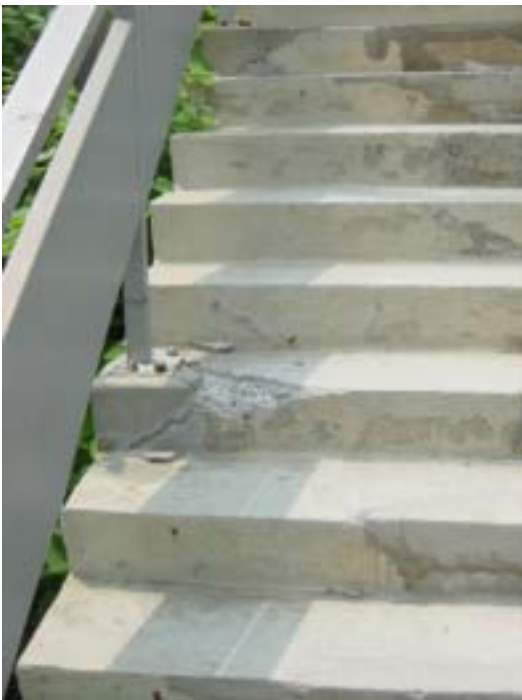
**More deterioration on steps to Hollow Tree Ridge Rd. at SW corner of station.**

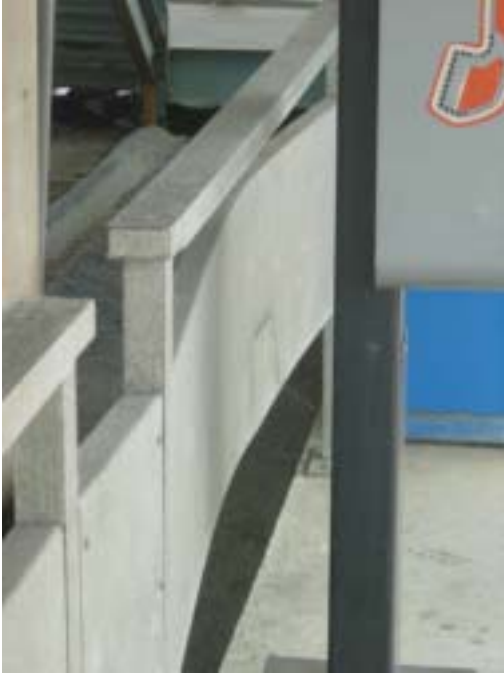
**Platform siding bowed outward.**

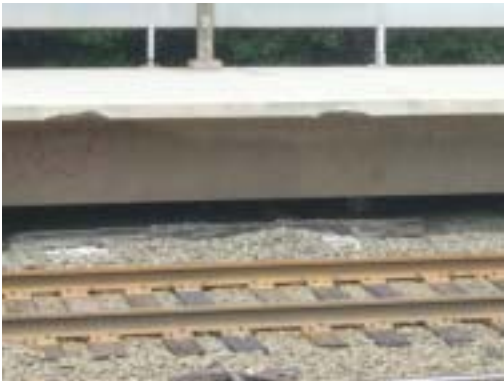
**Platform crumbling from beneath.**

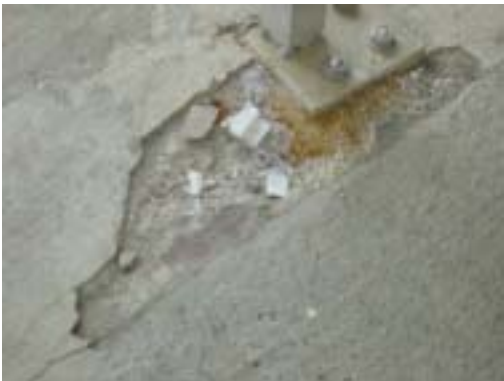
**More “divots” in the concrete.**
