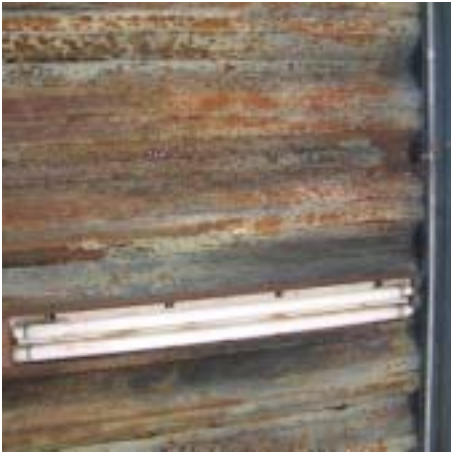
Rusted underside of the canopy.

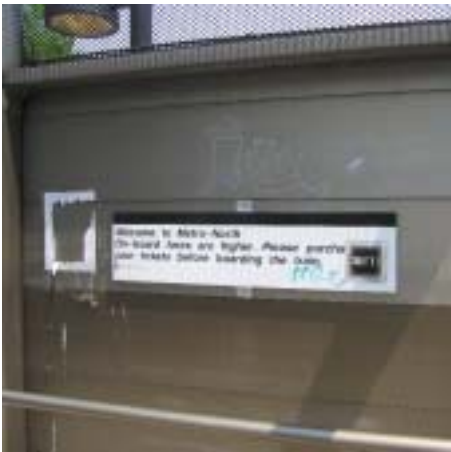
Defaced signs and graffiti

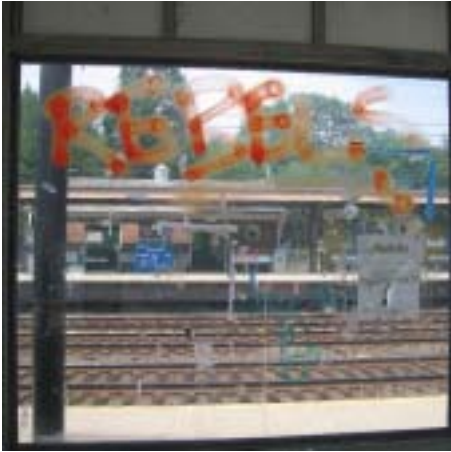
Graffiti seen from inside the waiting area

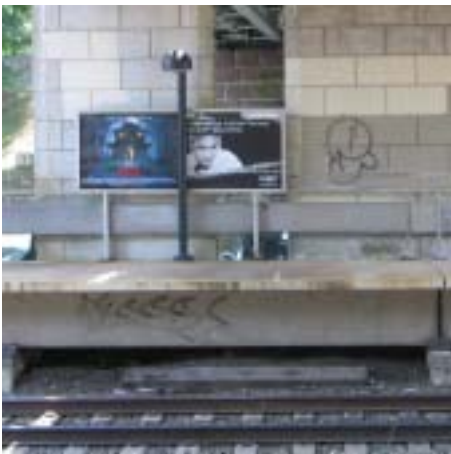
More graffiti

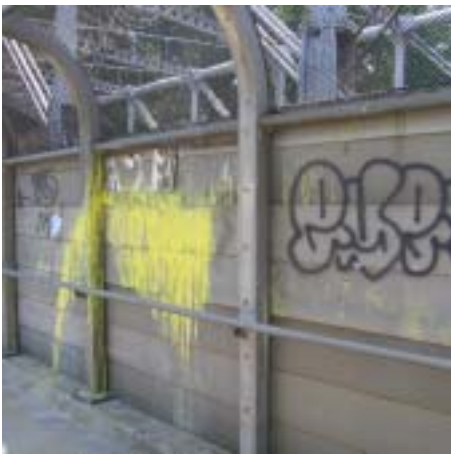
Artwork... or graffiti?

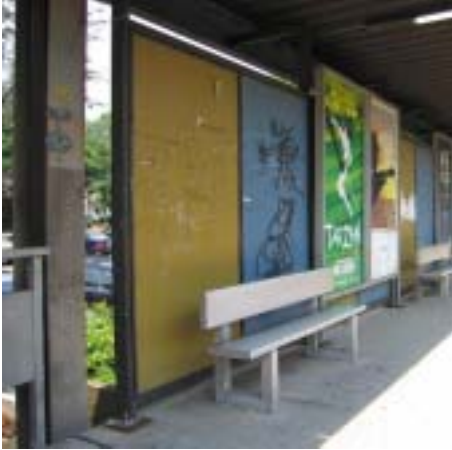
Definitely not art work.
