The Wreck of Second No. 5
May 7, 1951
by Ron Dawson

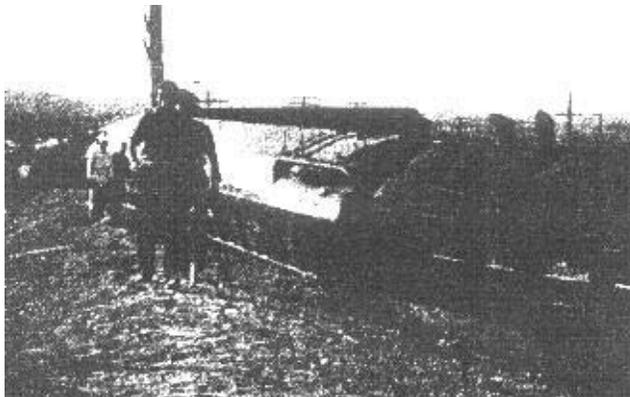
An injured crewman is helped away from the wreck.
