EVOLUTION OF THE AUTOMATIC FLAG-

MAN

ON THE P. E. RAILWAY SYSTEM

Taken from Electric Railway Journal - (1917-18)

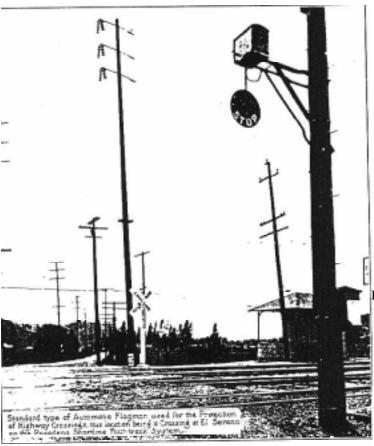
The first mechanical flagman was developed in the Company's own signal shop in 1910. This was a motor driven bell type. Later this device was taken over by an outside company and further developed for operation under type known as magnetic operation; a decided improvement.

The control system for operation of flagmen consists of trolley brush contactors, and high tension walking beam relay apparatus. Contactor trouble is the cause of 25% of the failures detected. It is the intention to overcome these failures by the introduction of a track instrument or contactor to supplant the present over-head trolley contactor used.
