The Wreck of Second No. 5
May 7, 1951
by Ron Dawson

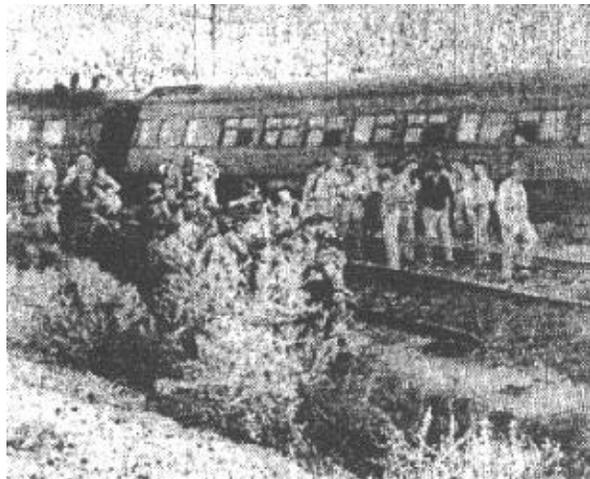
Examination of engine 703 and the cars of Second 5 after the accident disclosed no condition which could have contributed to the cause of the derailment. The throttle of engine 703 was in drifting position, the reverse lever was in position for forward motion, the automatic brake valve was in release, and the independent brake valve was in the running position. The engine truck, driving truck, and trailer truck assemblies were in good condition. The flanges and the treads of all wheels of the engine were of good contour, and the tread wear was negligible. All wheel-centers were tight on their axles and all tires were tight on their wheel centers, parallel to their companion tires. The lateral motion in the driving wheels was within the limits prescribed by the carrier. The driving box shoes and wedges were in good condition and well lubricated. The spring buffer assembly between the engine and the tender was in good condition, and the chafing faces were well lubricated. There were several abrasions on the outside of the counterbalances of the left No. 2 and 3 driving wheels, and on the outside face of the left No. 4 driving wheel tire, where these wheels had been in contact with the south ends of the ties.

Considering the absence of marks on the ties between the rails, the absence of flange marks on the high rail and the condition of the safety bar after the accident occurred, it is apparent that the engine and the tender were moving at overturning speed when the derailment occurred. It is found that this accident was caused by excessive speed on a curve.”⁵
